John Z. Duling Grant Final Report

Name:	John Goodfellow, Ward Peterson, Mark Hoenigman, and Gregory Dahle, PhD
Organization:	BioCompliance Consulting, Inc. (Project Lead)
Project Title:	Characterizing Branch Failure Modes
Grant #:	13-JD-01

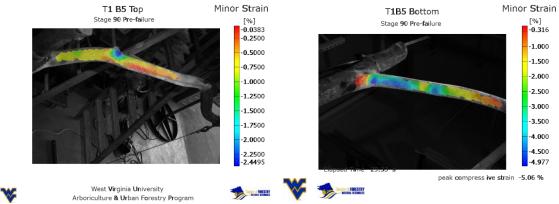
Figure 1. Pre-failure strain mapping along the top and bottom of sample T1 B5.

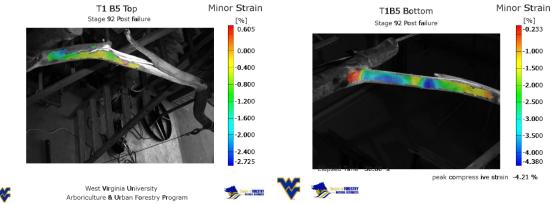
Figure 2. Post failure strain mapping along the top and bottom of sample T1 B5. Note that the failure occurred at a knot along the top portion of the lateral branch.
